RE: Summary Letter on Fire Performance of Polymer Based Brick-ties Exterior Wall Systems for Project F4749.01-121-24.

Intertek-ATI performed tests on exterior wall systems in accordance with a modified version of NFPA 285-12, *Standard Fire Test Method for Evaluation of Fire Propagation Characteristics of Exterior Non-Load Bearing Wall Assemblies Containing Combustible Components*. **Modifications included limited instrumentation data, smaller system dimensions, and the observation of anchor integrity.**

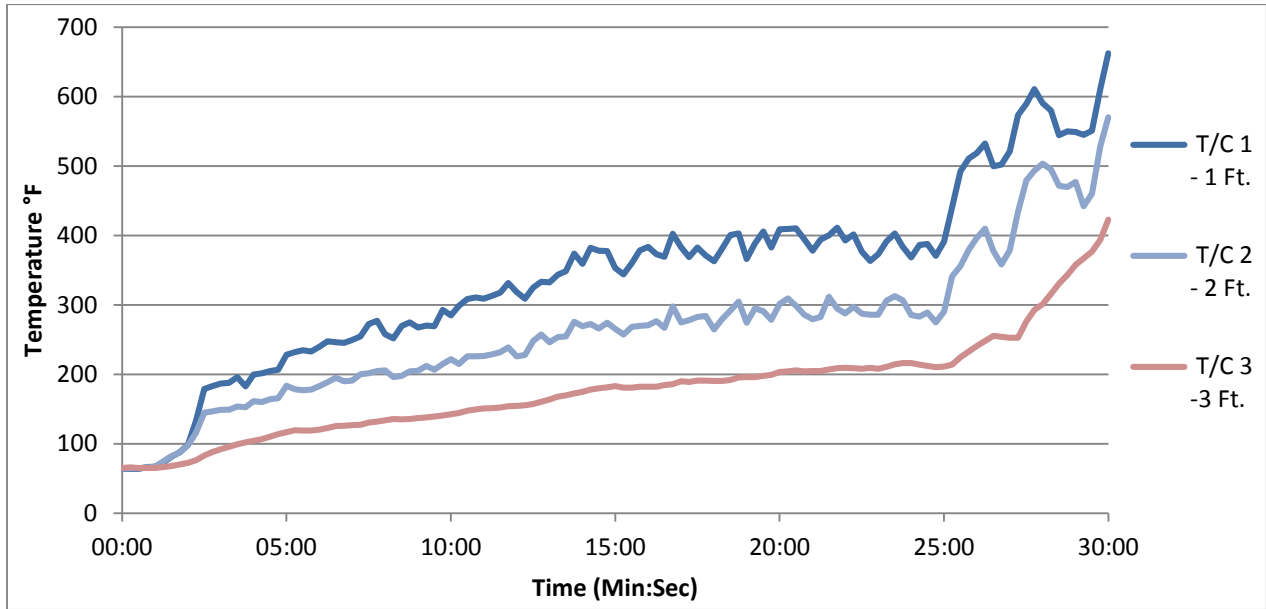
Graph No. 1
Air Cavity TC Data (First 30 Minutes)

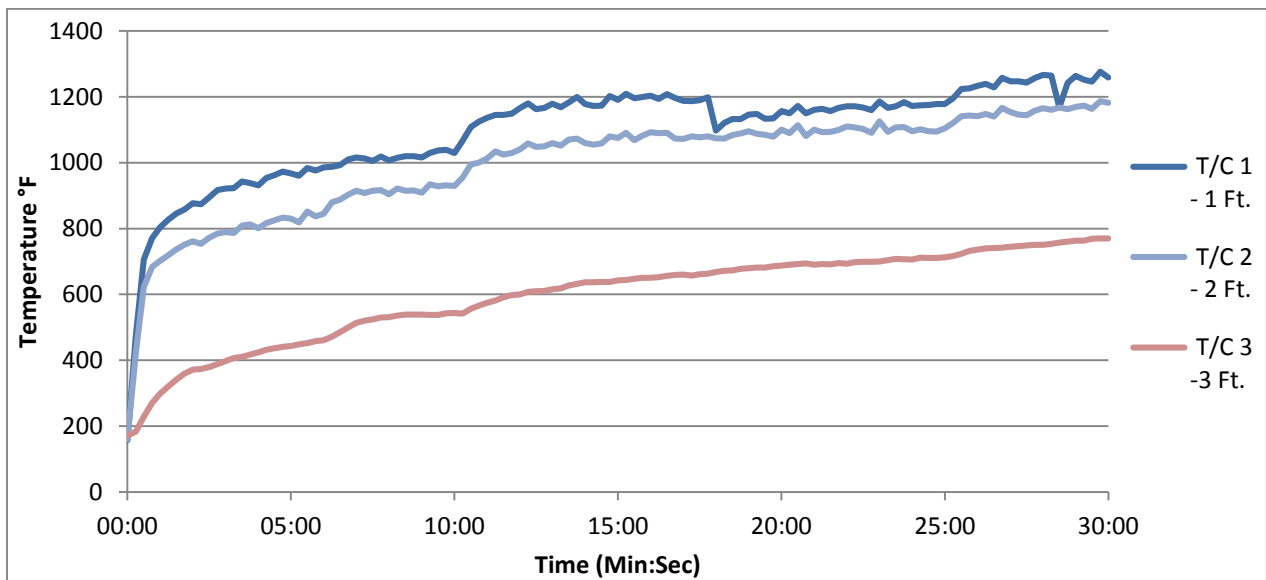
Graph No. 2
Air Cavity TC Data (Second 30 Minutes)

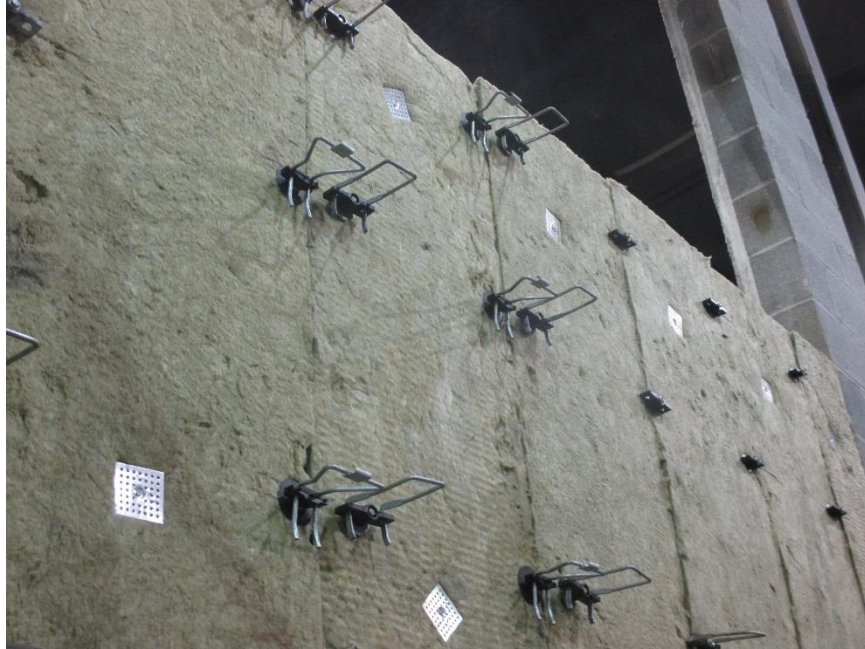
**Photo No. 1
Anchor Installation**

- Exterior Sheathing – 5/8 inch thick National Gypsum eXP Sheathing
- Air/Vapor Barrier – None Utilized
- Exterior Cladding Attachment – Every 24 inches vertically and 16 inches horizontally, both Hohmann & Barnard 2 Seal Thermal Wing Nut anchors with Hohmann & Barnard 4 inch ties along with nonspecific plastic thermal masonry anchors with 4 inch long metal ties were installed side by side and were fastened through the insulation, through the sheathing, and fastened to the steel studs.

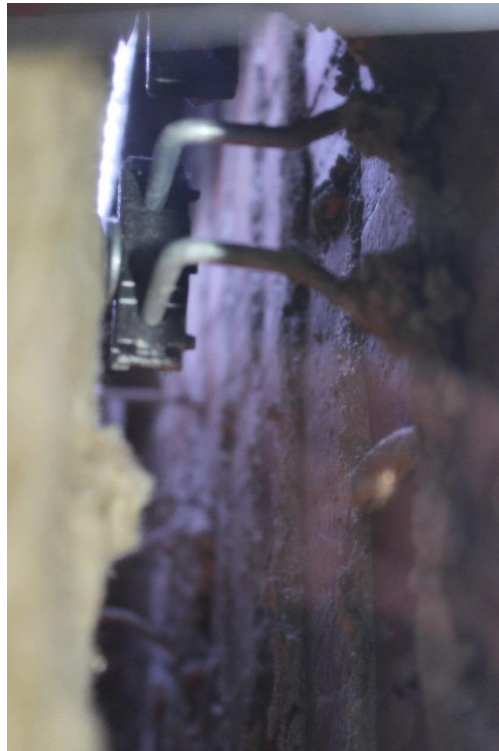
**Photo No. 2
Anchor Installation**

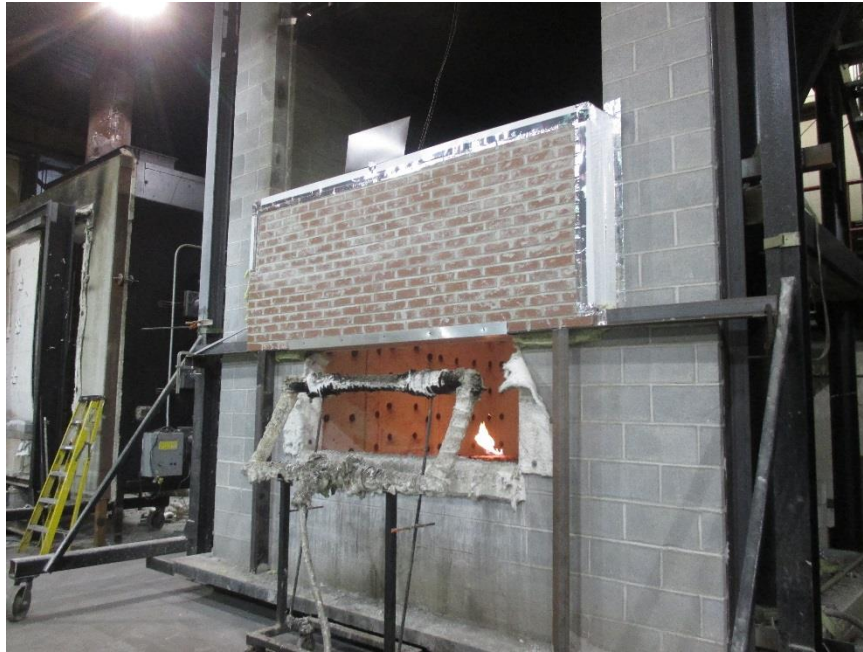
Photo No. 3
Complete Test Sample

- Exterior Cladding System – 3-5/8 in. x 2-1/4 in. x 7-5/8 in. Grade “A” bricks were used for the exterior cladding. The bottom row rested on the level surface of A 4 in. x 4 in. x 1/4 in. thick floating steel lintel at a distance of 2 in. from the exterior surface of the insulation. A mixture of Type S Mortar and Masonry Sand was used for all mortar joints.

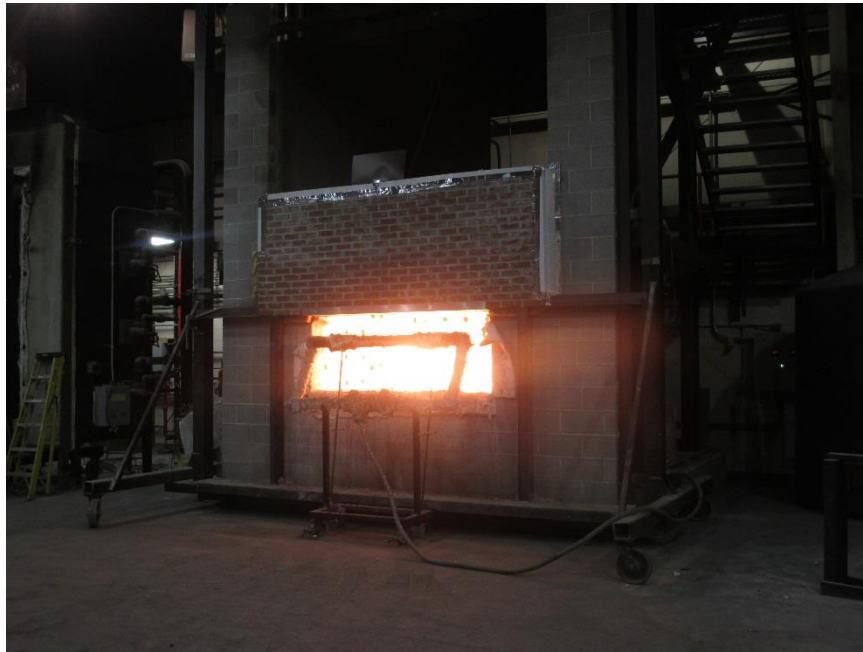
Photo No. 4
Beginning of Test

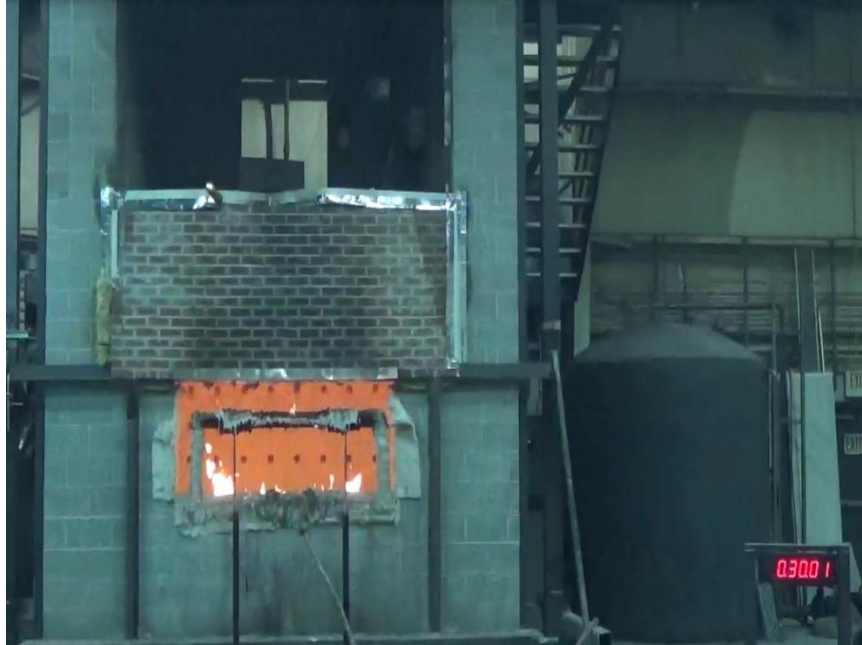
Photo No. 5
Test #2 End of First 30 Minute Exposure

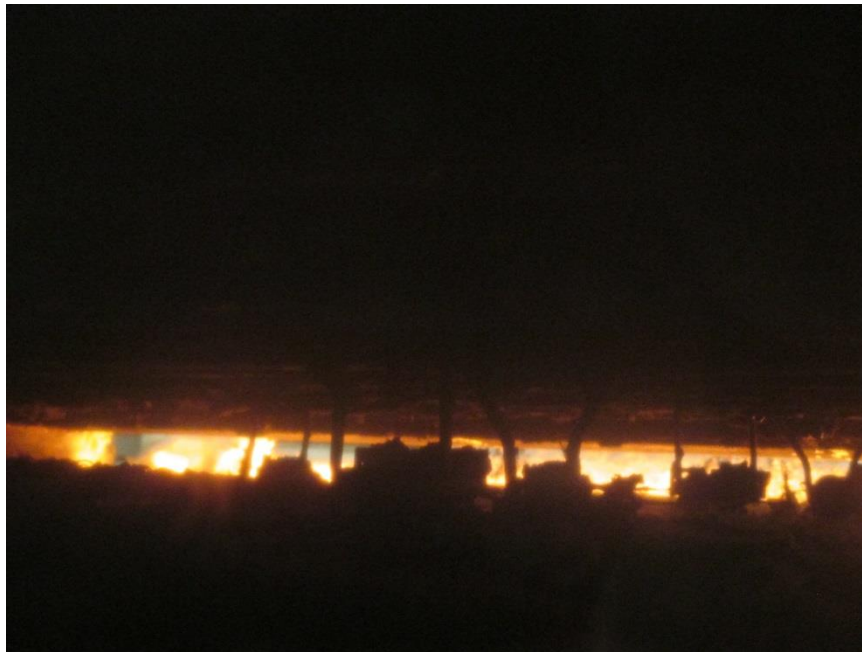
Photo No. 5
Air Cavity during Second Exposure

| Time (min:sec) | Observations |
|---|---|
| Post-Test | After the burners were extinguished, the window opening header flashing was removed and the wall assembly was exposed to additional fire exposure from the room burner. The duration of the exposure was also 30 minutes with the calibrated gas flows from the room burner. At the completion of the exposure, it was observed that the “all plastic” thermal wing melted while the steel reinforced thermal wing remained intact. See Photos 6 & 7 in Appendix B. |

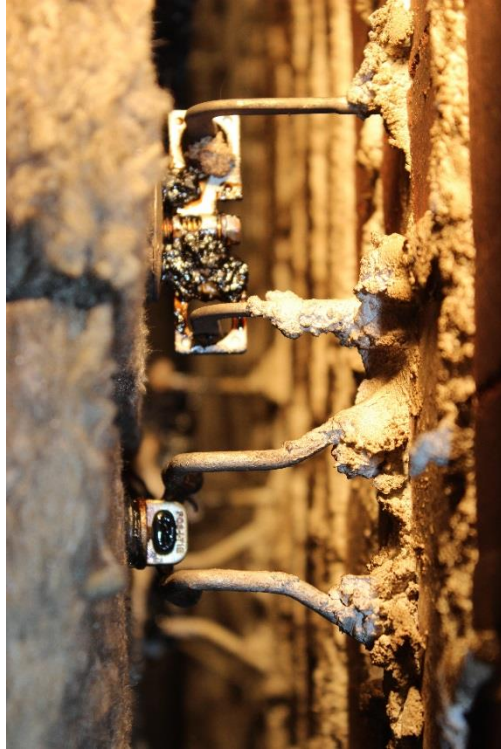
Photo No. 6
Brick Anchors and Ties (After Exposures)

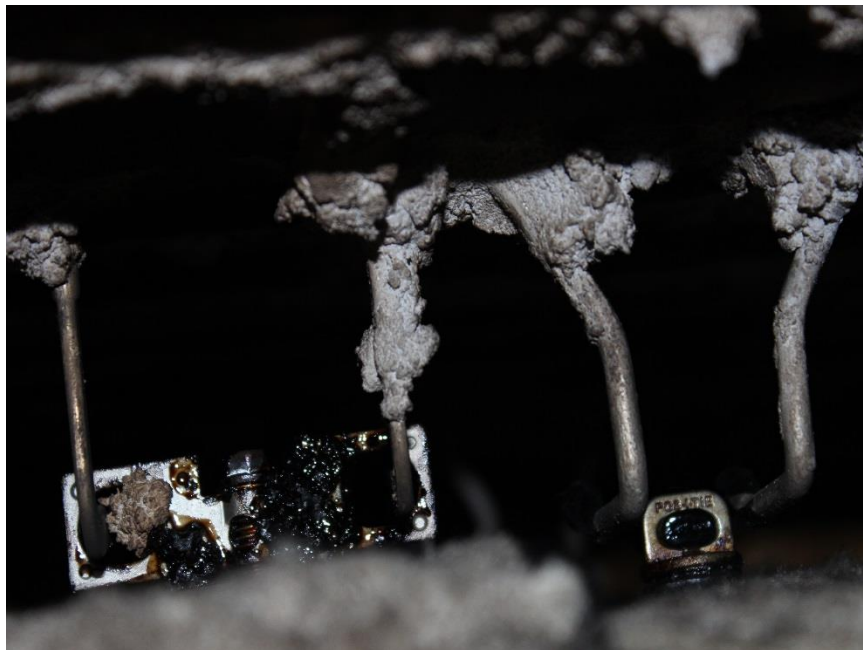
Photo No. 7
Brick Anchors and Ties (After Exposures)
